**THERMAL-STRUCTURAL  
EVALUATION OF  
Ti-6Al-4V  
THERMAL PROTECTION  
SYSTEM PANELS**

By H. L. Eidinoff and L. Rose

Prepared under Contract No. NAS 1-12277 by  
Grumman Aerospace Corporation  
Bethpage, New York 11714

NATIONAL AERONAUTICS AND SPACE ADMINISTRATION

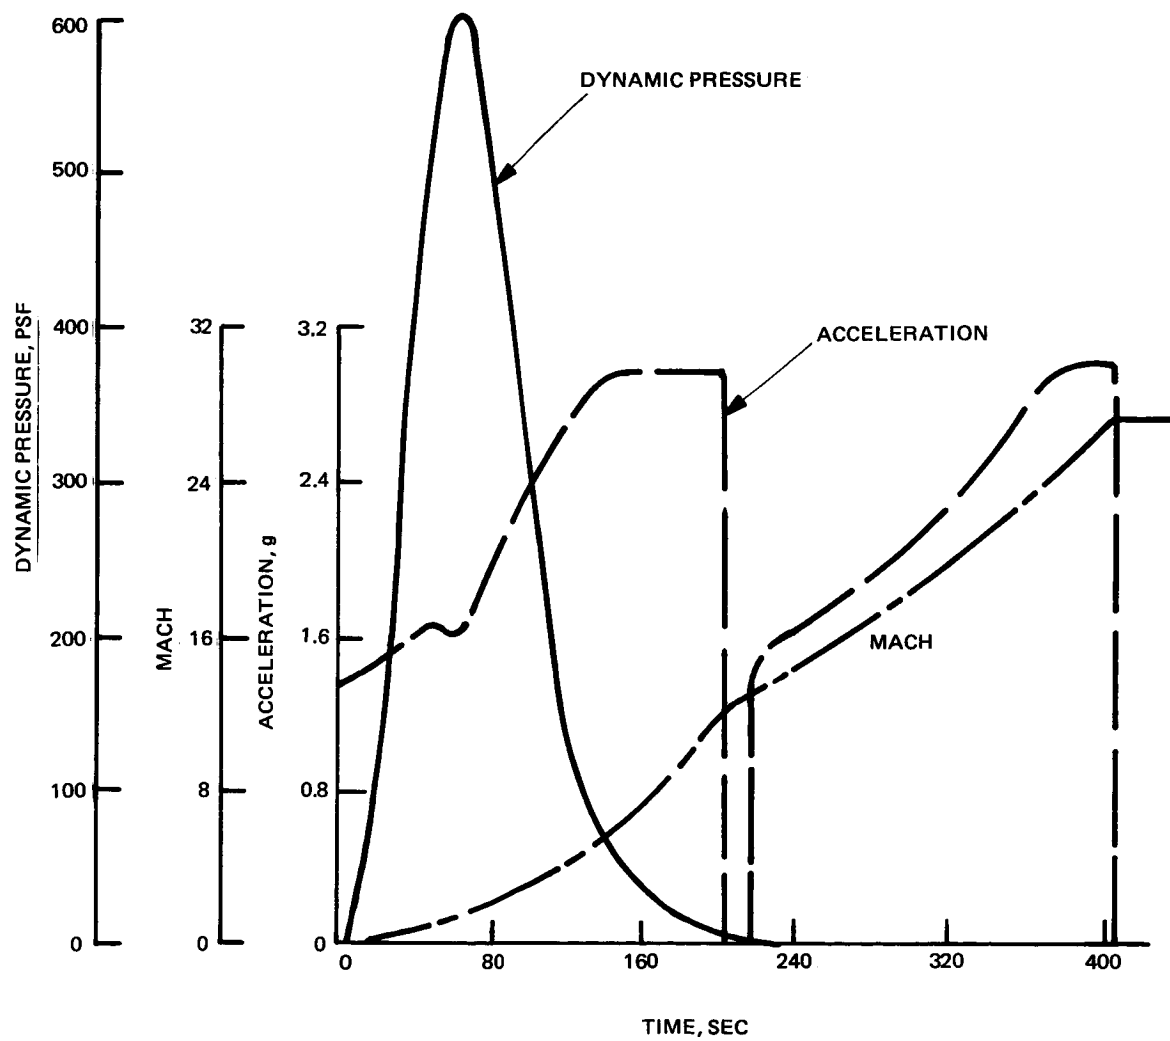
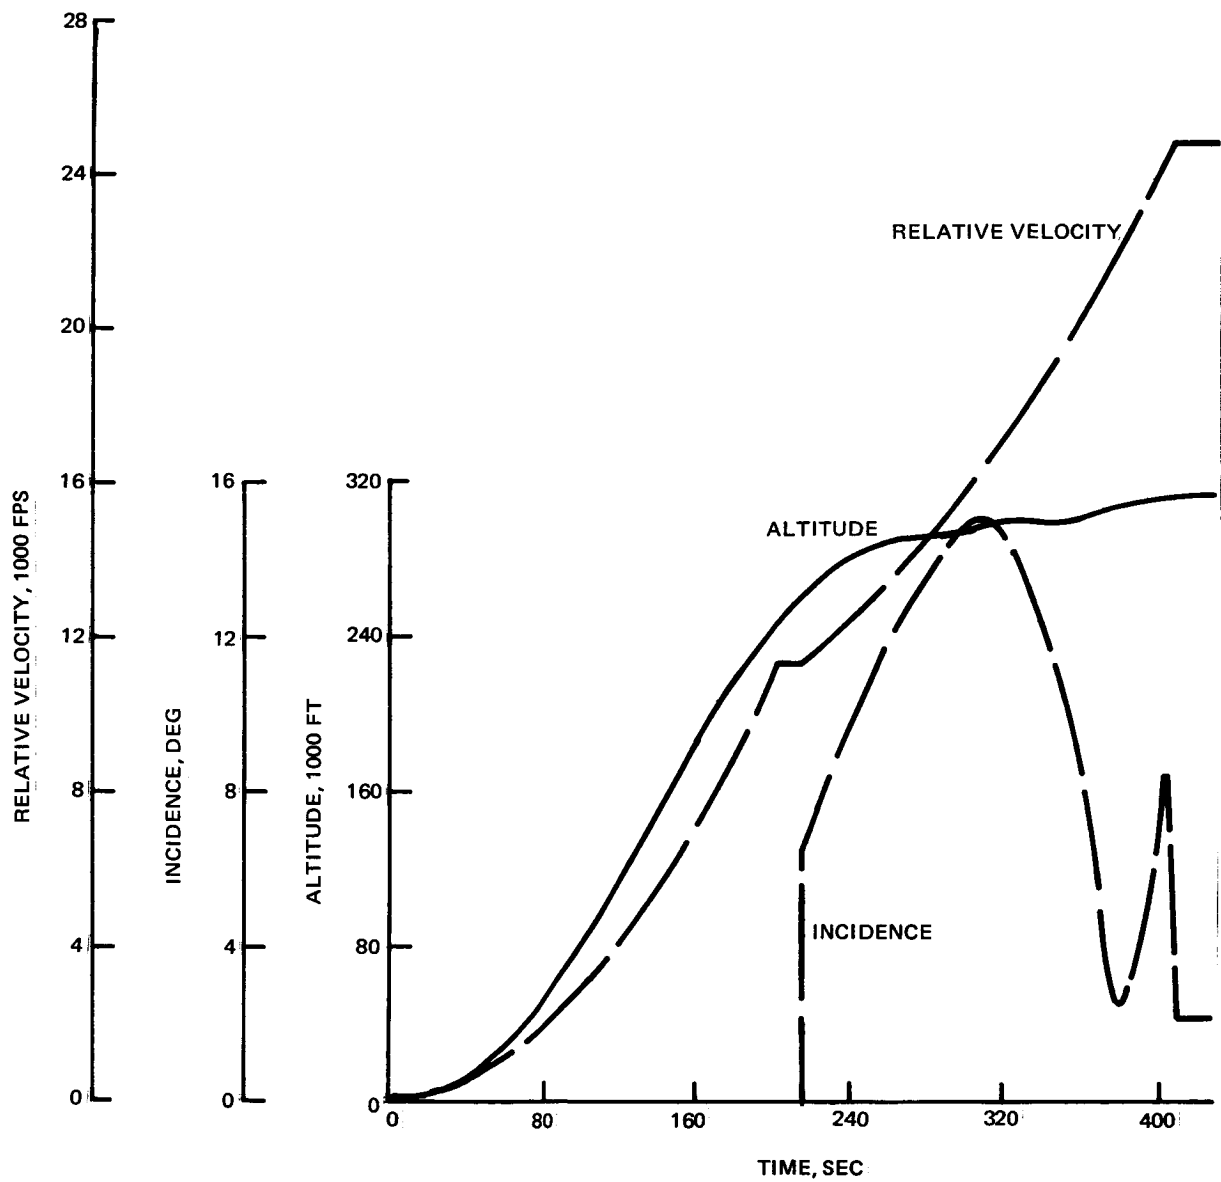
Trajectory parameters for the H-33 orbiter, which are reported in Ref 1, and are used to define the TPS environment used here, are shown in Fig. 3-2 through 3-5. Figures 3-2 and 3-3 define the ascent trajectory. The maximum dynamic pressure,  $29,000 \text{ N/m}^2$  (605 psf) occurs during ascent at Mach 1.25 and an altitude of 10,050 m (33,000 ft). Figure 3-4 gives vehicle reentry trajectory parameters; Fig. 3-5 gives the local surface equilibrium temperature and surface pressures for the design point 120 inches behind the nose. This point, which is noted on Fig. 3-1, was considered typical for the TD Ni-20Cr panel environment. The maximum surface temperature here is  $1200^{\circ}\text{C}$  ( $2200^{\circ}\text{F}$ ). The design conditions are taken from Ref 1, where the H-33 orbiter is defined in detail, and are:

Fig. 3-2 Ascent Trajectory Parameters

Fig. 3-3 Ascent Trajectory Parameters

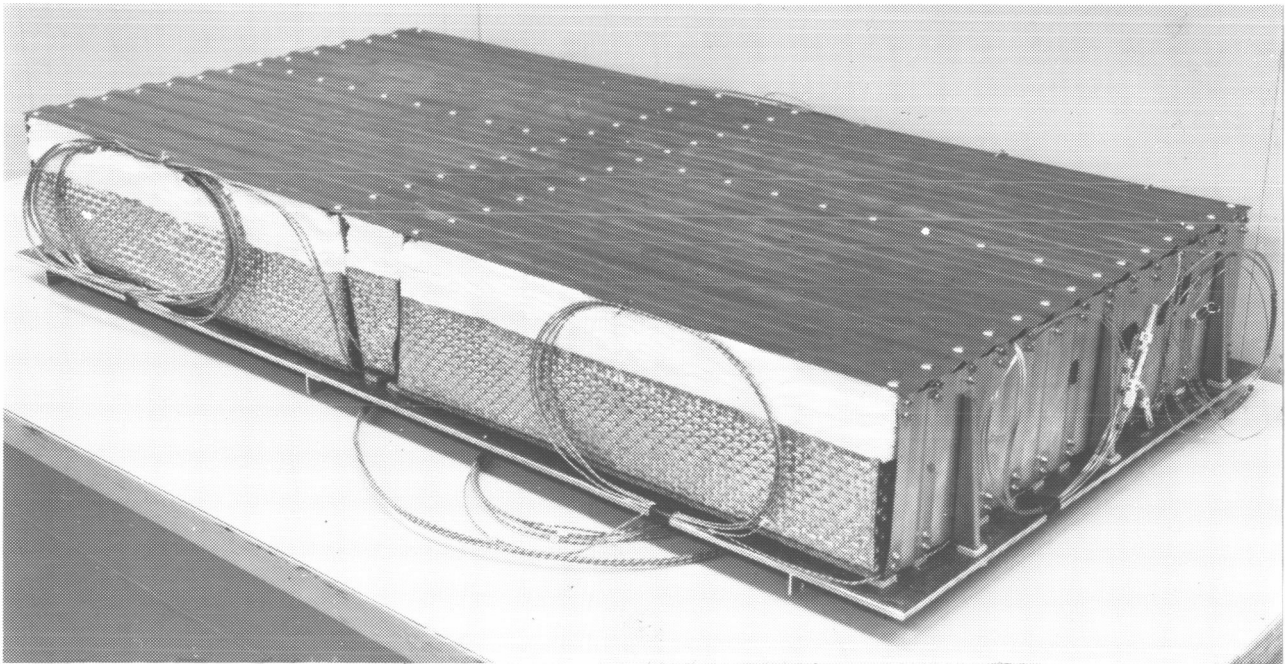
A photograph of the assembled test article is shown in Fig. 3-8. It shows the metallic frontface, an aluminum backface plate, metallic standoff supports, and a two-layer insulation system sandwiched between these components. The coils of wire shown are instrumentation leads. A design concept drawing is presented in Fig. 3-9.

Fig. 3-8 Test Article

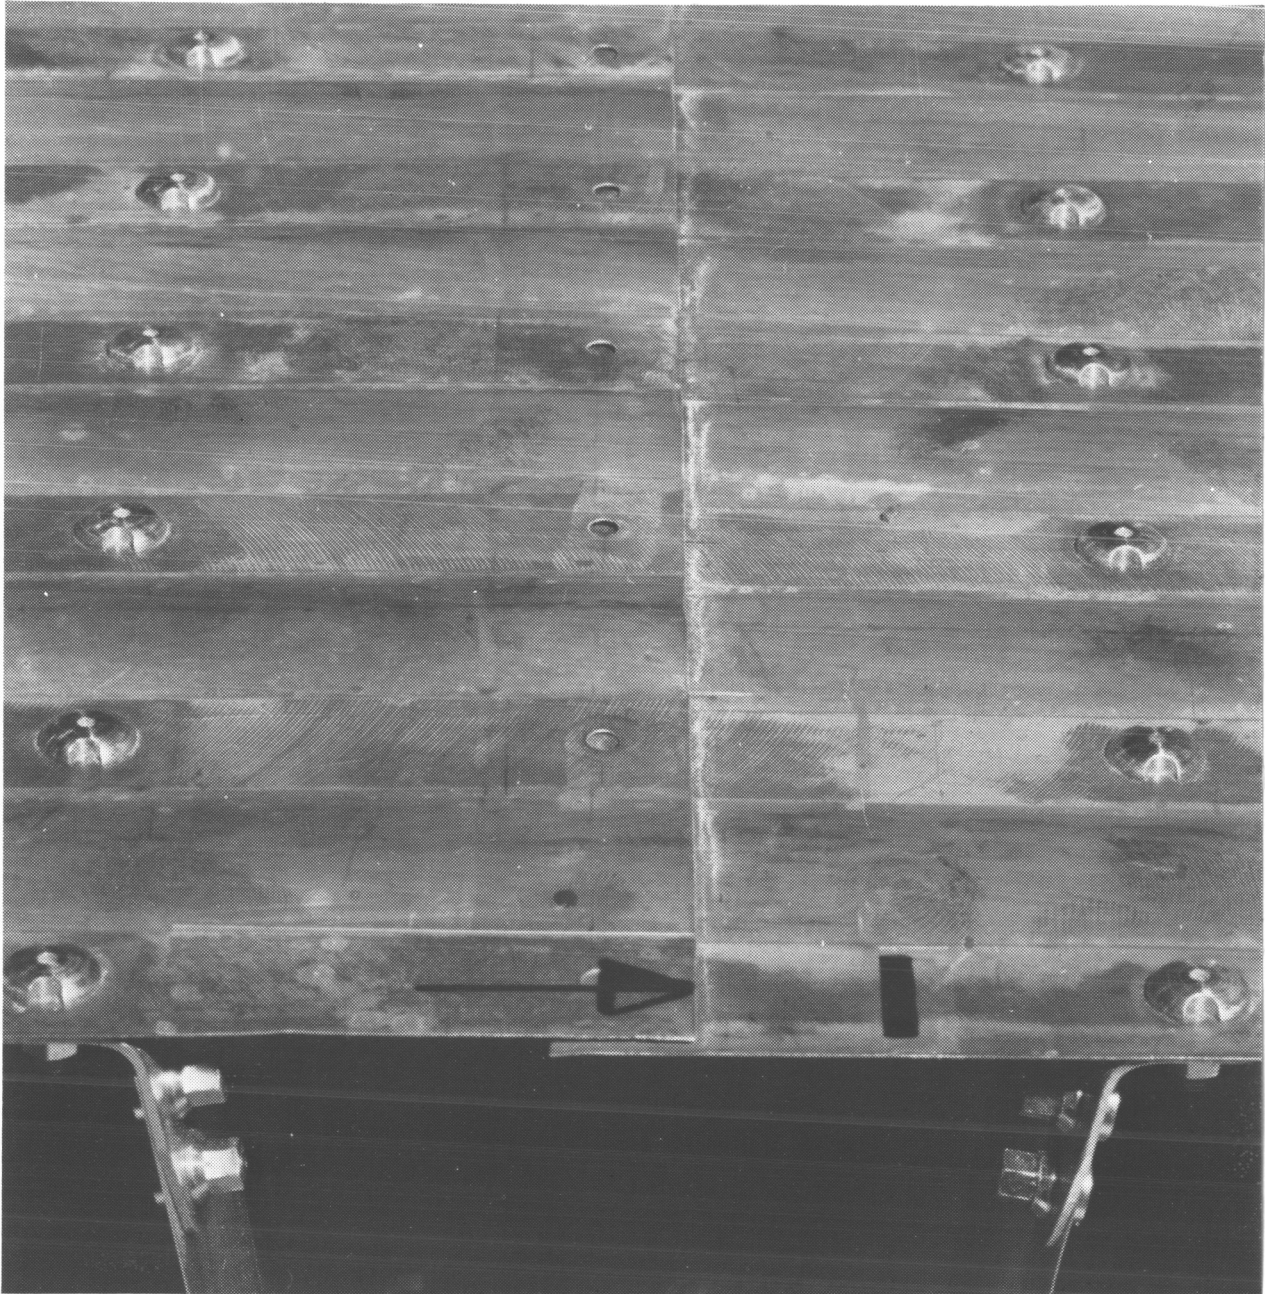
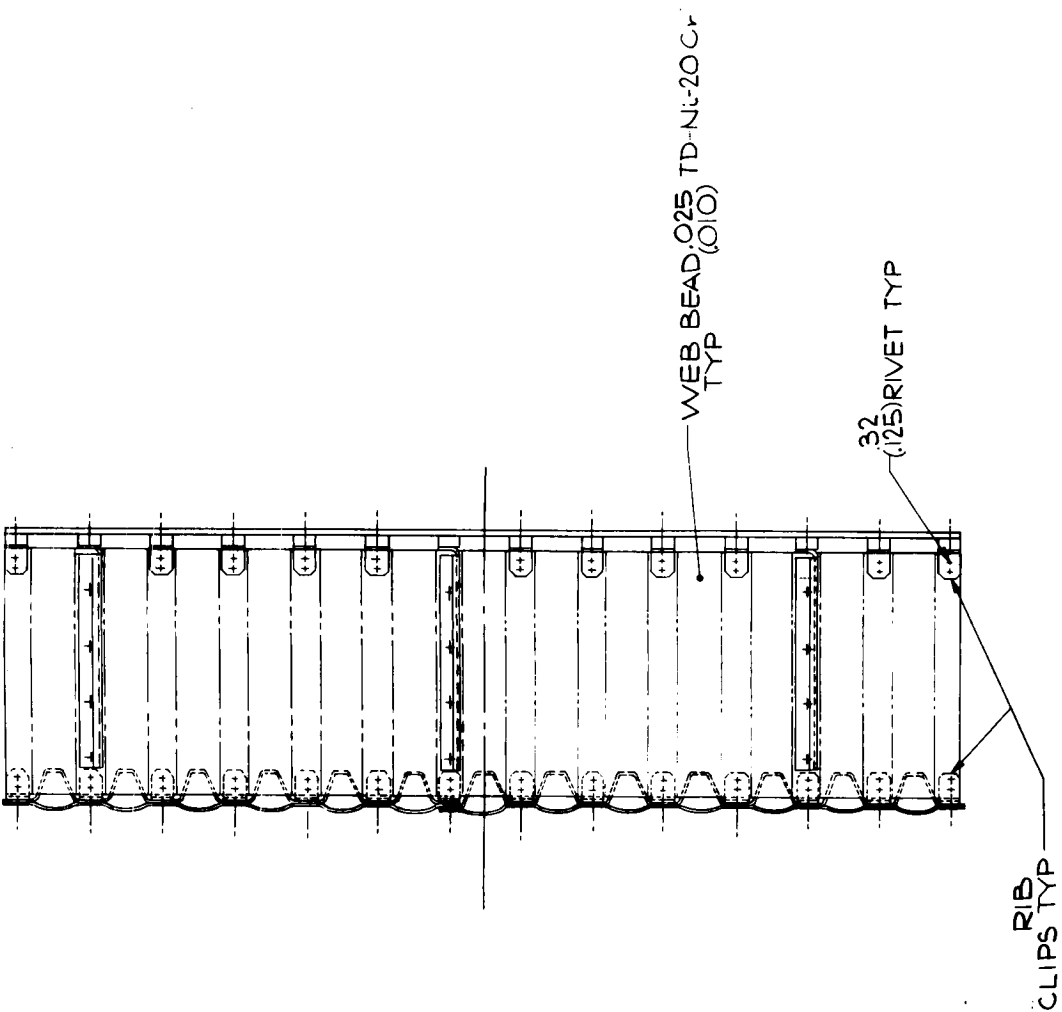
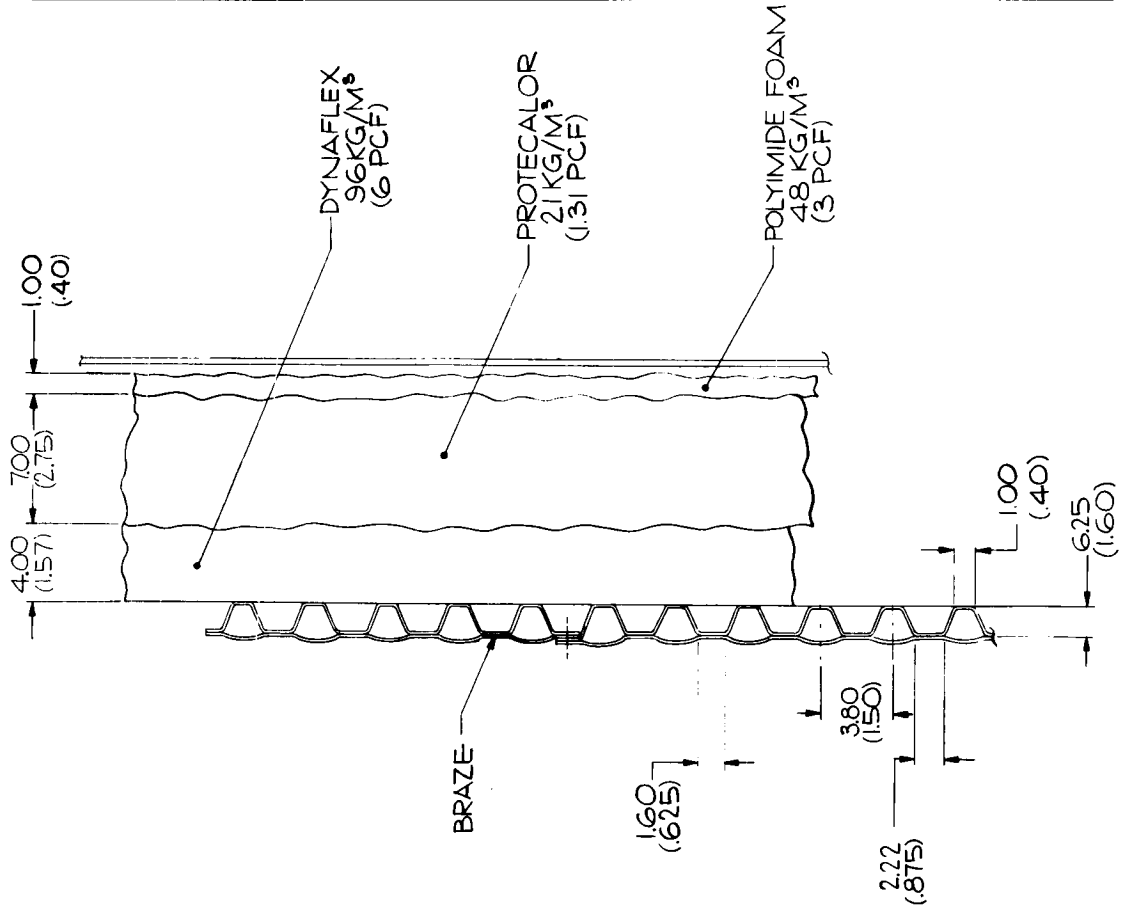
Fig. 3-10 Expansion Joint Detail

The test article represents the intersection of four 50.8-cm (20-in.) square heat-shield panels. A longitudinal expansion joint and a lateral panel splice are incorporated to verify feasibility of these design features. Each panel consists of a beaded 0.025-cm (0.010-in.) corrugation. These two formed sheets are joined along

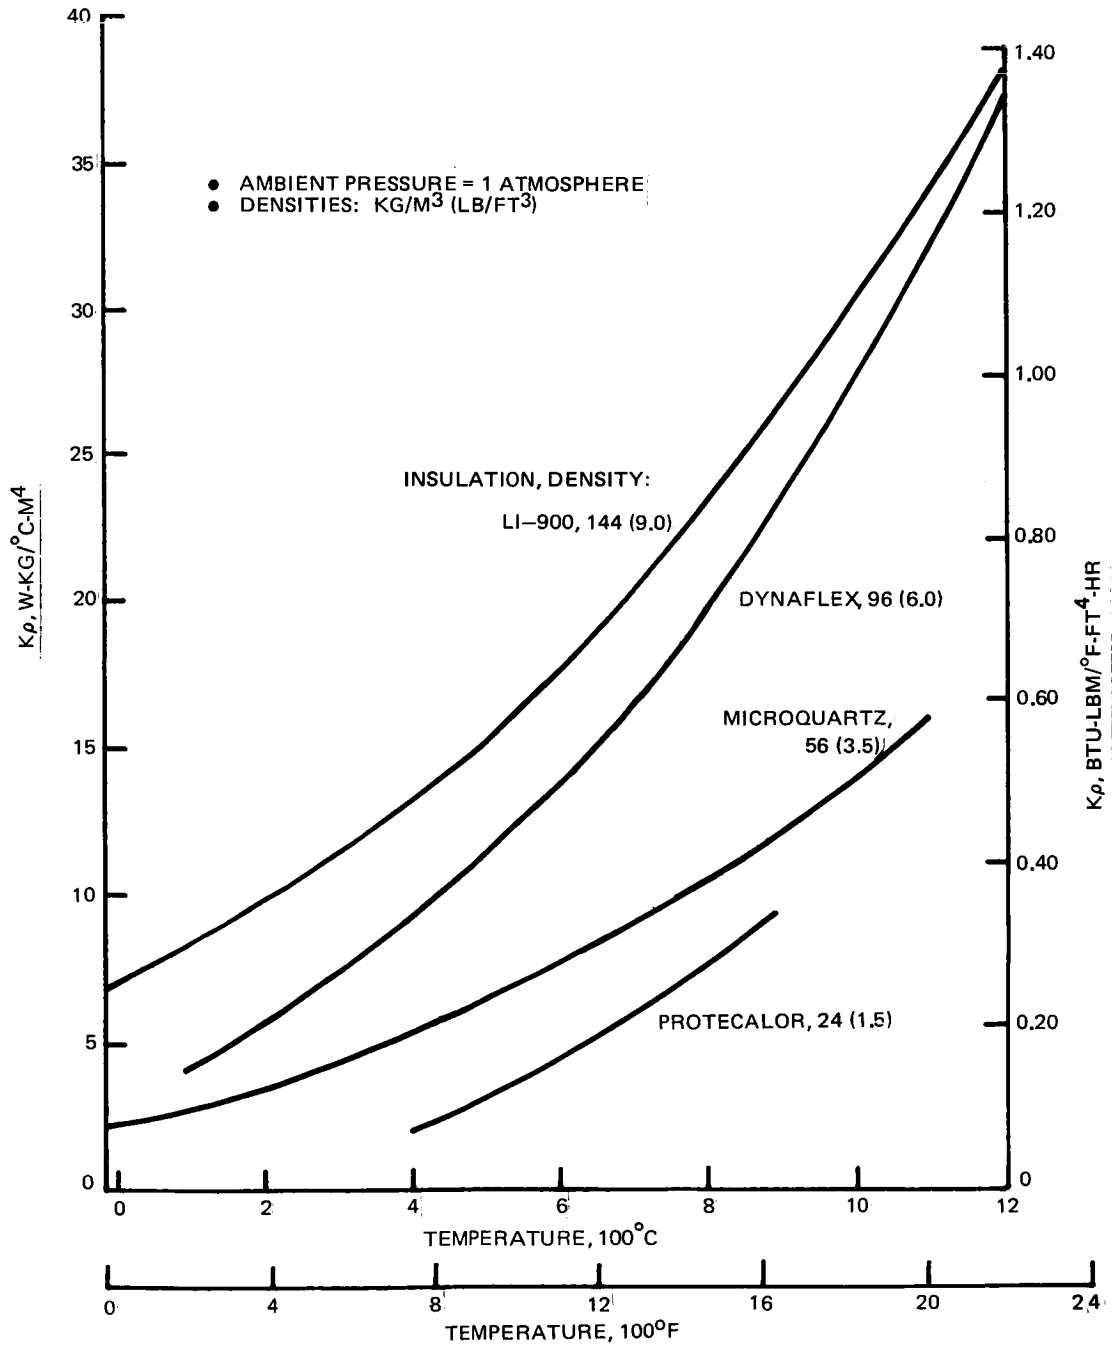
Dynaflex, manufactured by the Johns-Manville Company, has a density of  $96 \text{ kg/m}^3$  (6.0 pcf), and was selected for use in the temperature range of  $900\text{--}1200^\circ\text{C}$  ( $1650\text{--}2200^\circ\text{F}$ ). Because there was no TD Ni-20Cr foil available that could be used for bagging needed to prevent moisture absorption by the insulation, the layer was inserted without a metal foil case. The second layer of insulation is the Protecalor. This system consists of a series of very thin reflective screens separated by layers of lightweight quartz wool called Astroquartz. For the temperature range of  $600\text{--}900^\circ\text{C}$  ( $1100\text{--}1650^\circ\text{F}$ ), the reflective screens are gold-plated micarta  $20 \mu\text{m}$  (0.0008 in.) thick. From  $400\text{--}600^\circ\text{C}$  ( $750\text{--}1100^\circ\text{F}$ ), the reflective screens are aluminum  $20 \mu\text{m}$  (0.0008 in.) thick. The Astroquartz, which is made by the French company Quartz et Silice, is made of fibers drawn from pure silica and has a density of  $16 \text{ kg/m}^3$  (1.0 pcf). The total density of the Protecalor is  $21 \text{ kg/m}^3$  (1.31 pcf), making it an extremely lightweight insulation system. The high thermal efficiency of this insulation system is seen by comparing its specific conductivity ( $k\rho$  - product) to that of Microquartz and Dynaquartz, as shown in Fig. 3-11.

Fig. 3-11 Insulation Specific Conductivity

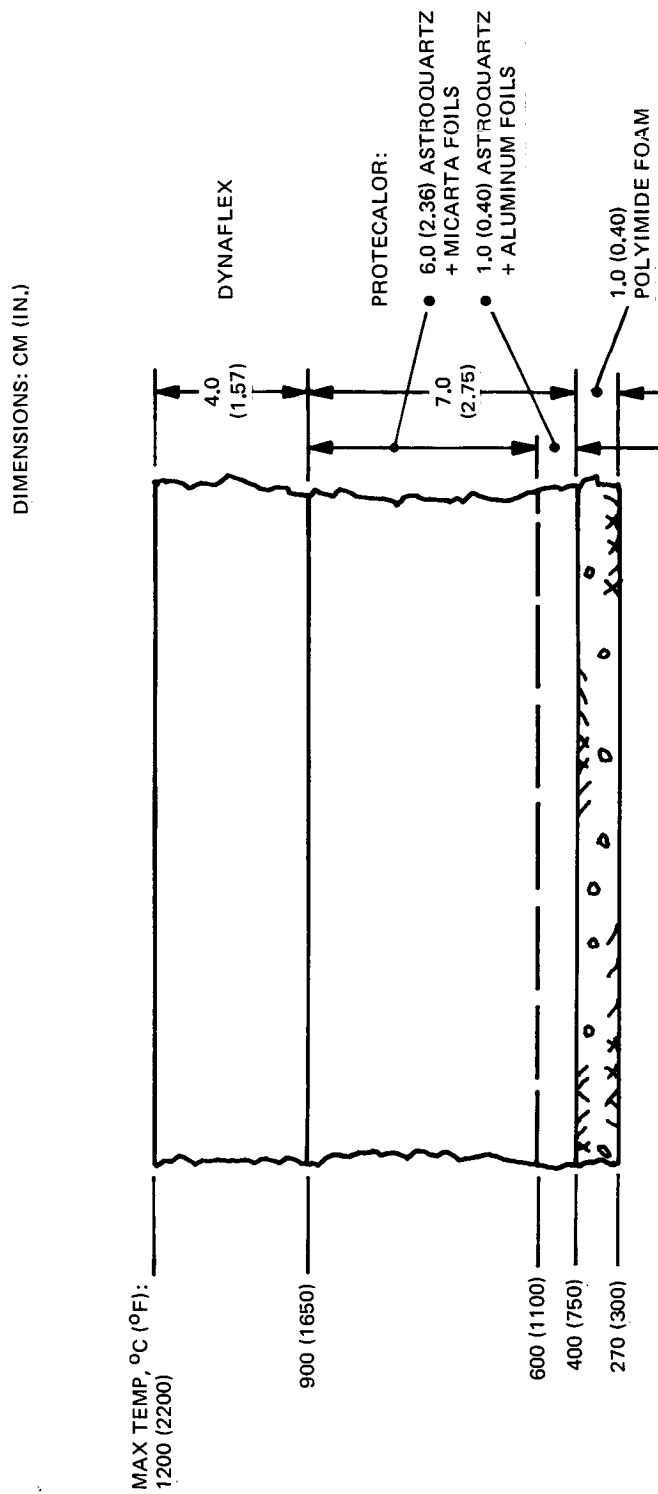
- DYNAFLEX, 96 (6)
- PROTECALOR, 21 (1.31)
- POLYIMIDE FOAM, 48 (3)

Fig. 3-12 Panel Insulation System

The entire Protecalor system is enclosed in a protective bag that improves handling and prevents excessive moisture absorption. This bag has a top and sides made of  $76 \mu\text{m}$  (0.003 in.) Inconel foil. The bottom of the bag is made of 10.0-mm (0.40-in.) polyimide foam, weighing  $48 \text{ kg/m}^3$  (3.0 pcf) and having an upper temperature limit of  $400^\circ\text{C}$  ( $750^\circ\text{F}$ ). The polyimide foam serves to rigidize the insulation package, is moistureproof, and is also an effective insulation. The insulation system and temperature range are shown in Fig. 3-12 and the detailed unit weight breakdown is shown in Table 3-1.

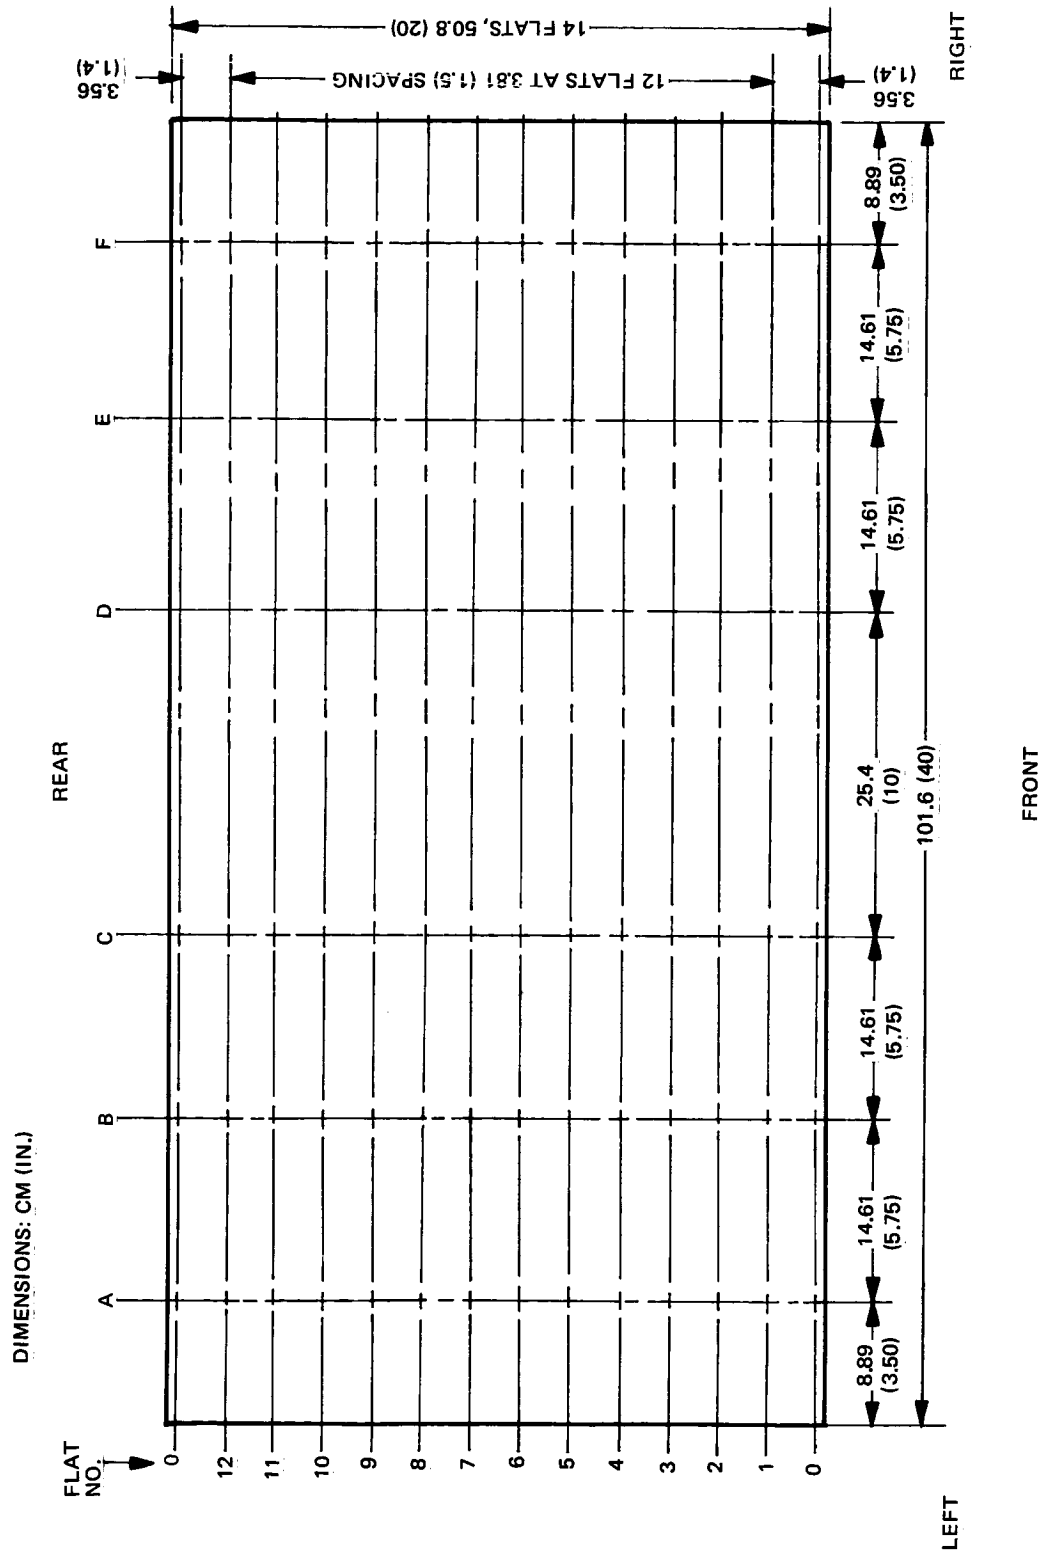
A diagram showing the loading wire locations on the test article frontface is presented in Fig. 4-4. The load wires are joined along the lettered rows in the upper levels of the whiffle-tree. This means that if a loading wire in Row A fails, its load will be transferred to the adjacent loading wire in Row A. Hence, the load for a lettered row will be constant until all the loading wires in that row fail. Then the load for the row will be transferred to an adjacent row.

Fig. 4-4 Loading-Wire-Number Locations

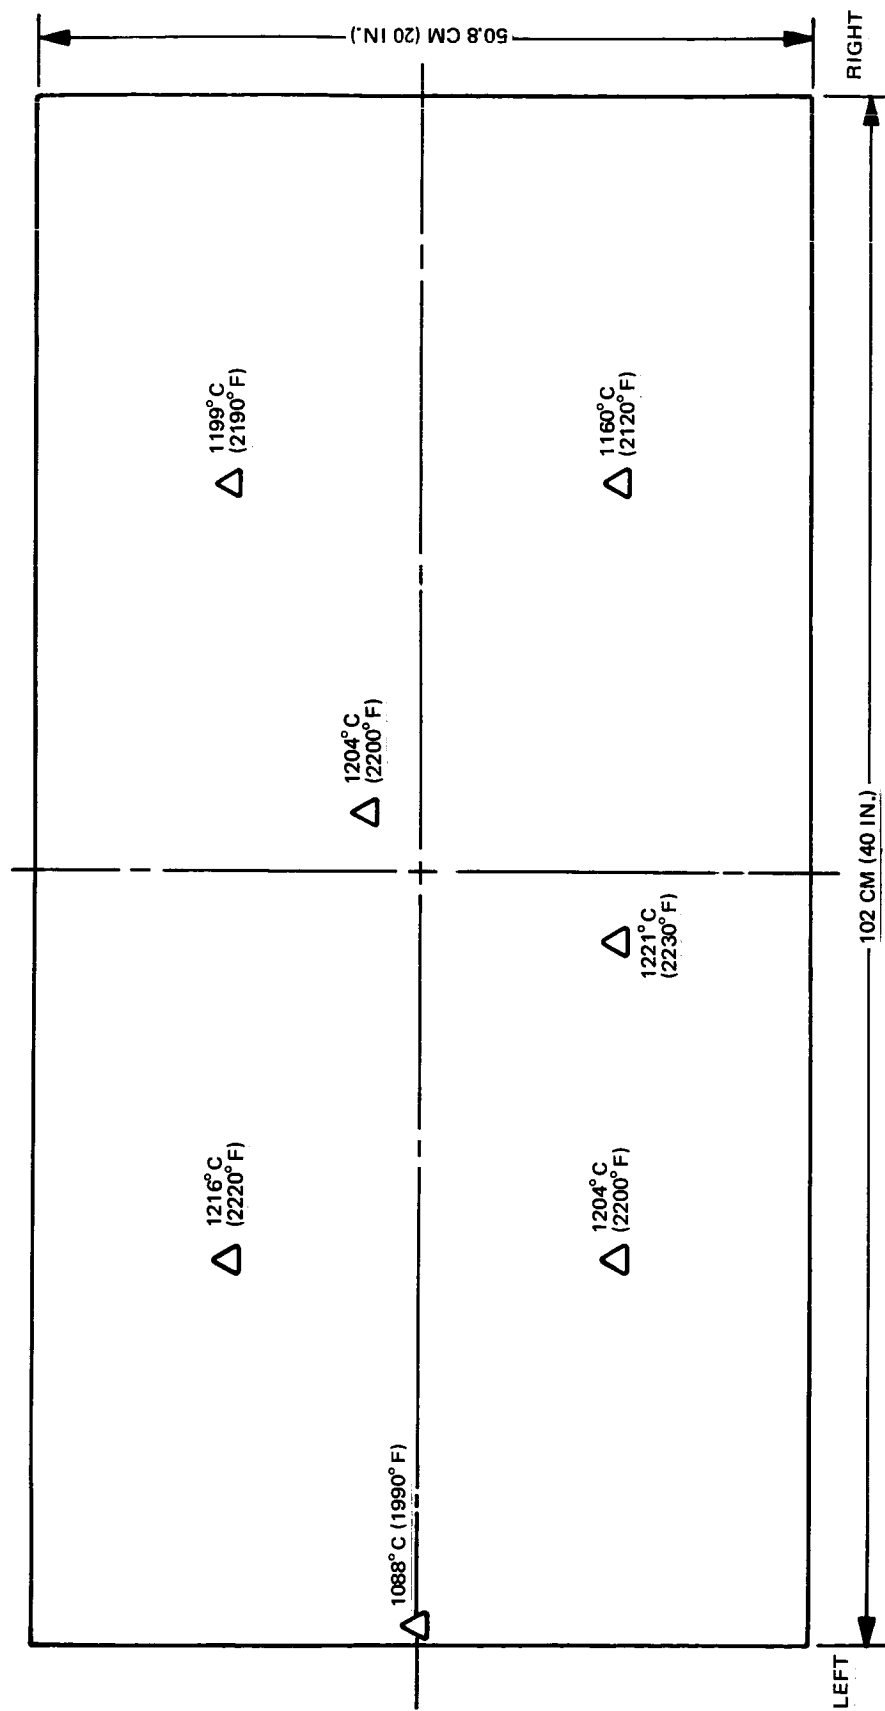
The first 10 cycles, which consisted of reentry heating conditions only, were intended to verify the thermal performance of the insulation blanket, to verify the uniformity of the panel surface temperatures, and, in general, to check the heating array and its controller. The heating array performed very well, producing a nearly uniform  $1200^{\circ}\text{C}$  ( $2200^{\circ}\text{F}$ ) over the panel frontface. On a typical temperature cycle, the temperature over six surface thermocouples varied by less than  $60^{\circ}\text{C}$  ( $110^{\circ}\text{F}$ ), from  $1220$ – $1160^{\circ}\text{C}$  ( $2230$ – $2120^{\circ}\text{F}$ ). The peak surface temperatures during cycle No. 2 are shown in Fig. 5-1 at their respective surface locations.

Fig. 5-1 Maximum Surface Temperatures Map

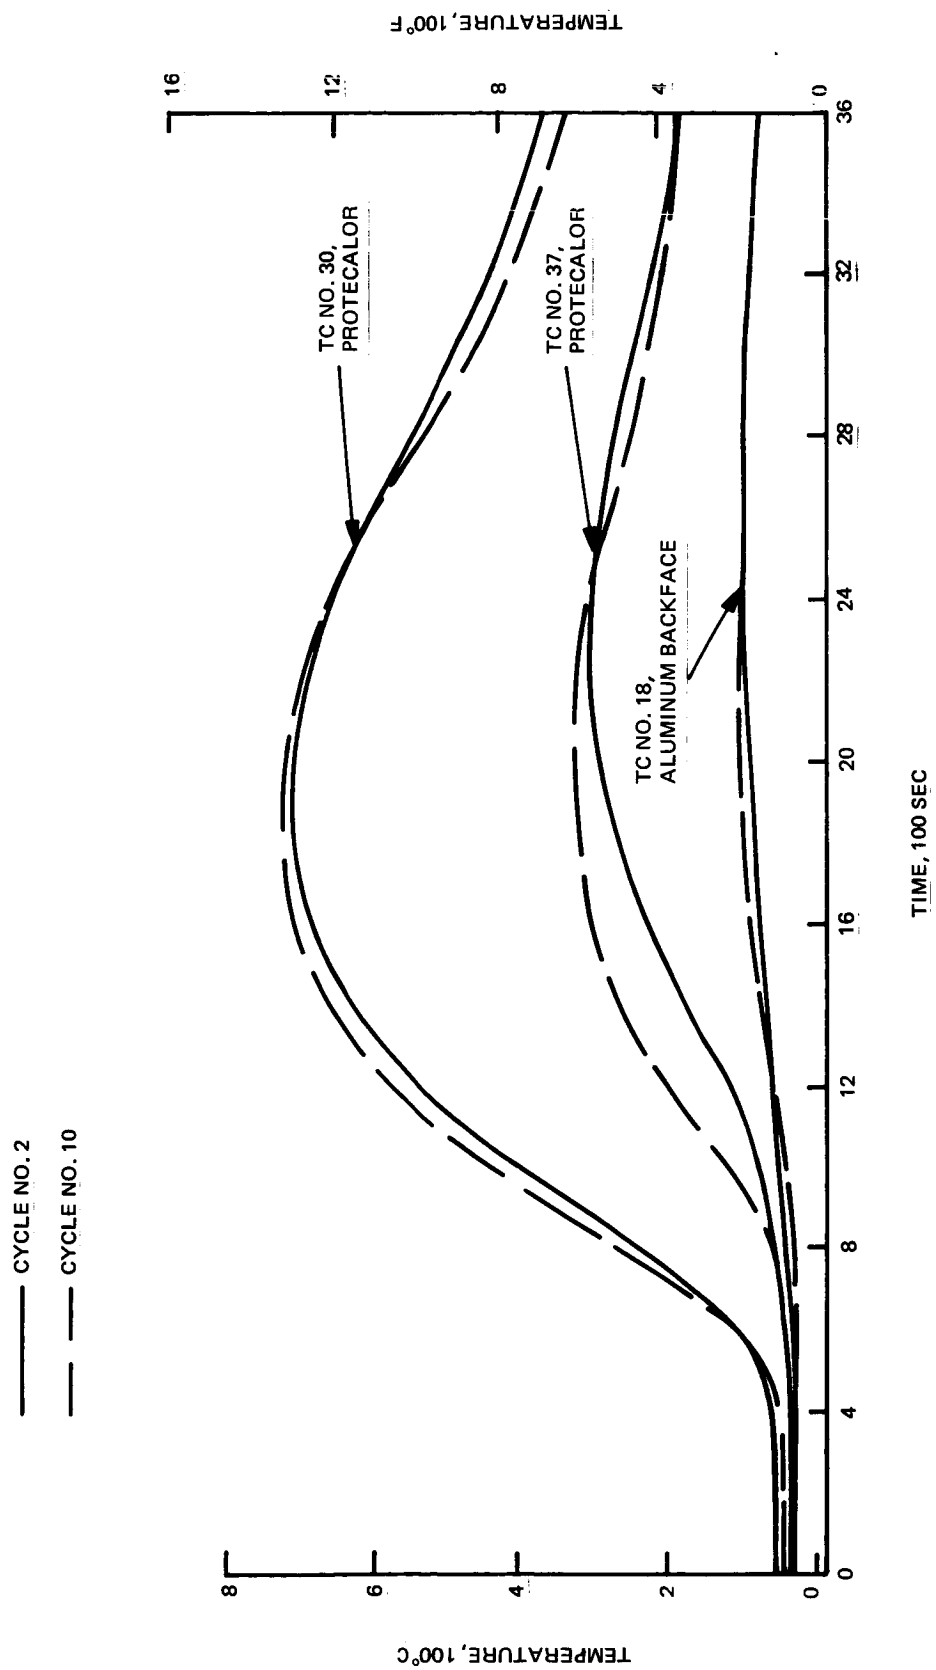
The insulation did not exhibit appreciable degradation during the first 10 cycles, as demonstrated by comparing the backface temperature response of cycles 2 and 10. These are very similar, as can be seen in Fig. 5-3, where plots are presented of the temperature response of the two extremities of the Protecalor and the aluminum backface. The Protecalor maximum temperature did not exceed  $715^{\circ}\text{C}$  ( $1320^{\circ}\text{F}$ ), and the aluminum heat sink never exceeded  $90^{\circ}\text{C}$  ( $200^{\circ}\text{F}$ ).

Fig. 5-3 Insulation Temperature Response—Effect of Thermal Cycling

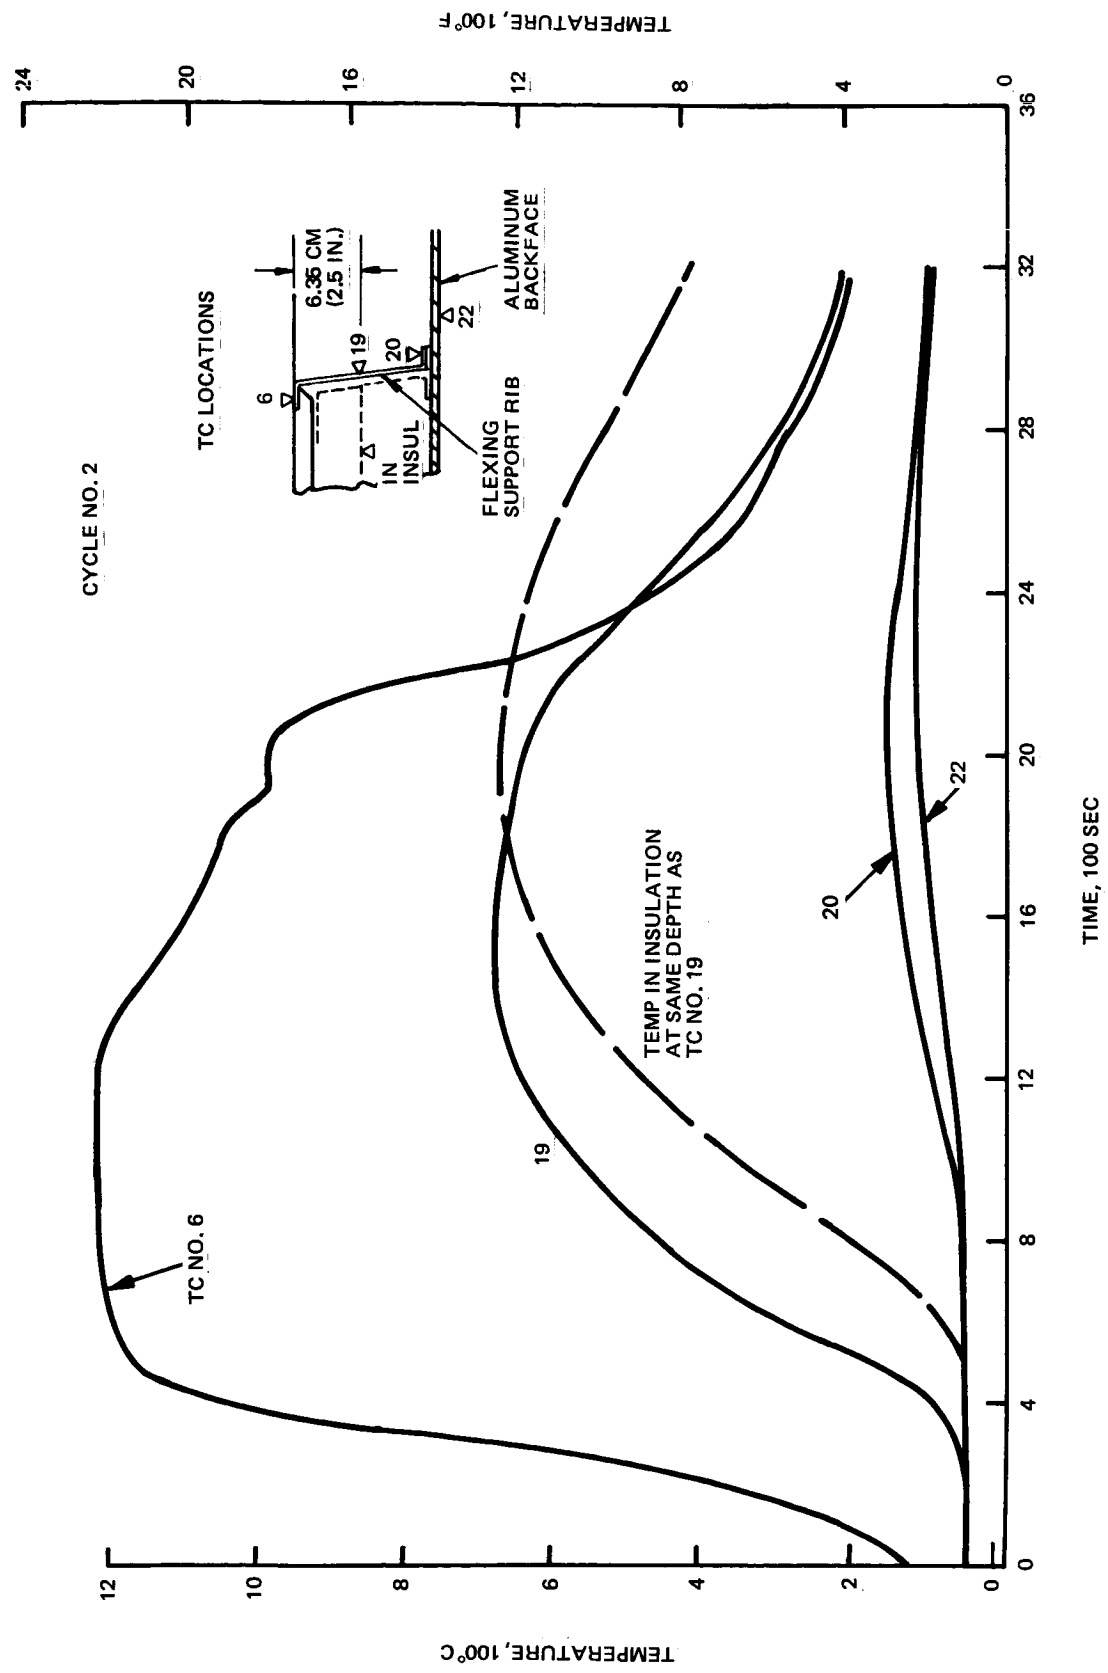
Temperatures on the flexing support rib are shown in Fig. 5-5 and are taken from cycle No. 2. They are typical of all support rib results. Note that the peak temperature for TC 19 is 677°C (1250°F), about the same value as the insulation temperature at the identical depth relative to the frontface. The heat leakage through the support ribs was apparently of manageable proportions.

Fig. 5-5 Support Rib Temperature Response

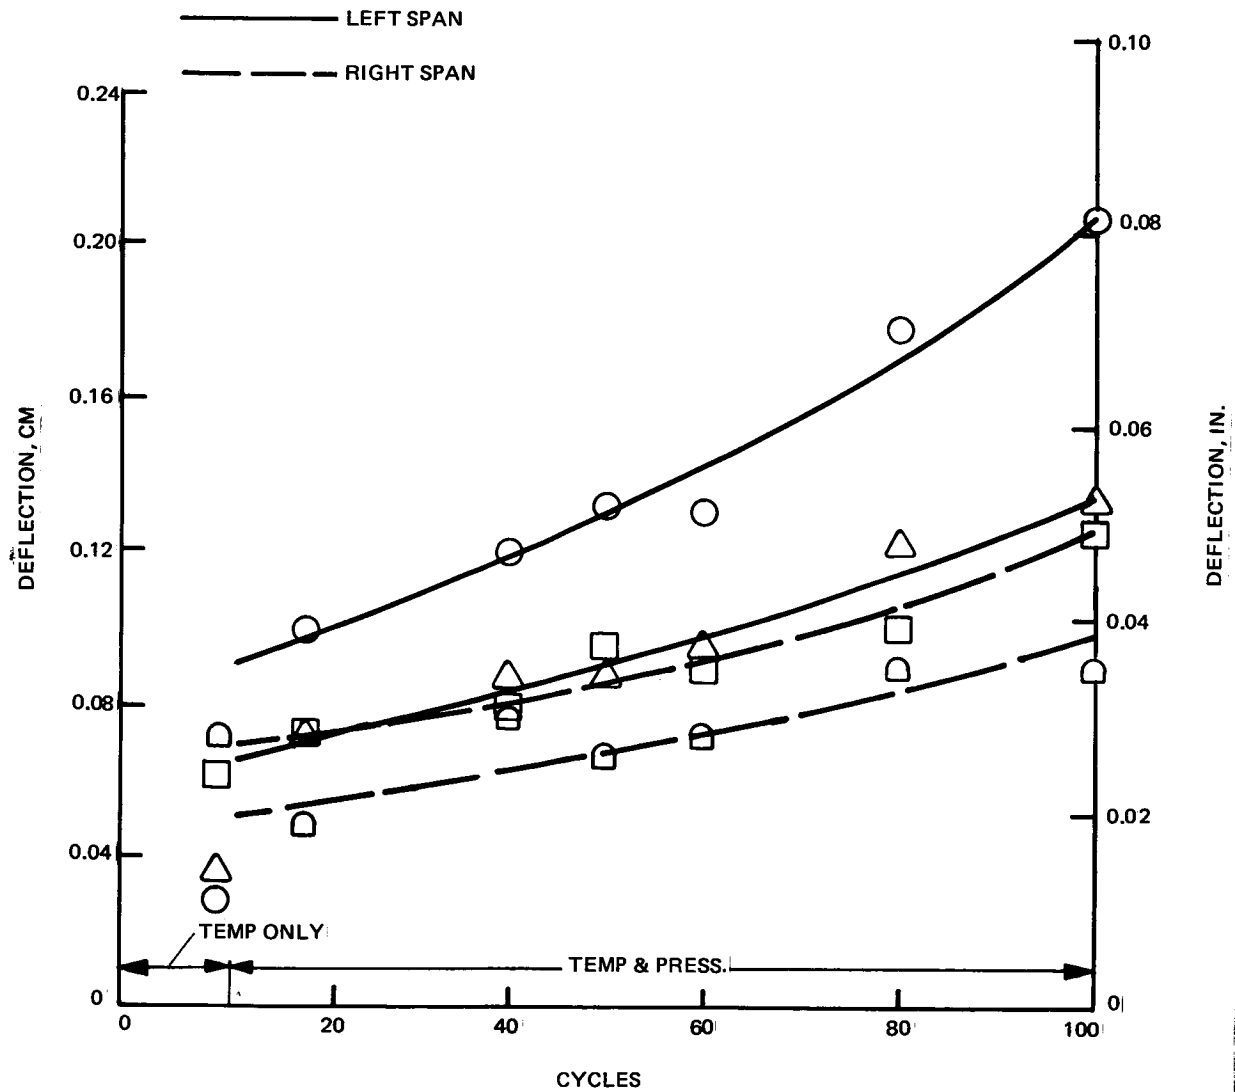
Flatness surveys were made at various intervals to measure the permanent set caused by plasticity effects - primarily, high-temperature creep. Flatness survey data for the mid-span points along flats No. 4 and 9 are plotted in Fig. 5-10 as functions of the number of test cycles. Here, the initial support settlement is subtracted from the left span. However, the left span has a greater permanent deflection than the right. This is probably due to the fact that the temperatures over the left span were slightly higher than those on the right, and caused more creep to occur in the beads and corrugations. It is observed that there is measureable permanent deflection after the first 10 cycles, in spite of there having been no pressure load applied. This is probably due to the effect of residual stresses built into the panel during manufacture and assembly combined with the thermal stresses produced by the applied heat load.

Fig. 5-10 Permanent Deflection, Midspan

There is another significant increase in permanent deflection of the left span and a rearrangement of permanent deflection in the right span between cycles 10 and 19. This is apparently due to residual stress acted upon by the applied mechanical load introduced in cycle 11, as well as the thermally induced loads. The residual stress distributions are altered by the application of the simulated pressure load. From cycles 19 to 100, the increase in permanent deflection is more orderly and is indicative of the behavior which results from cyclic creep. This phenomenon was observed during cyclic testing of Haynes-25 panels by Grumman and is reported in Ref 7 and 11. Note that the magnitude of these permanent deflections is relatively small in all cases.

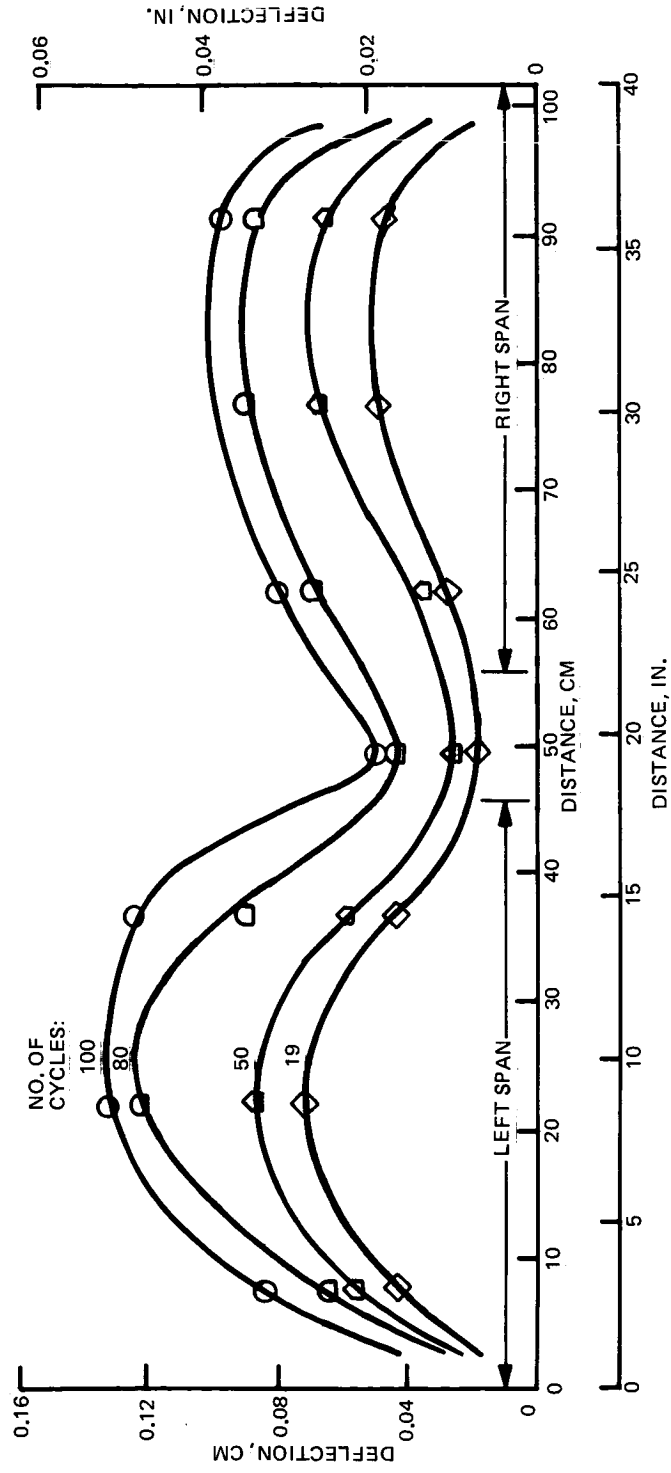
Figure 5-11 shows the permanent deflection plotted in the spanwise direction for flat No. 4, a typical flat. Here, again, the difference in deformation between the left and right spans is illustrated. This type of behavior was also observed during cyclic testing of Haynes-25 panels and was reported in Ref 7 and 11.

Fig. 5-11 Permanent Deflection, Flat No. 4

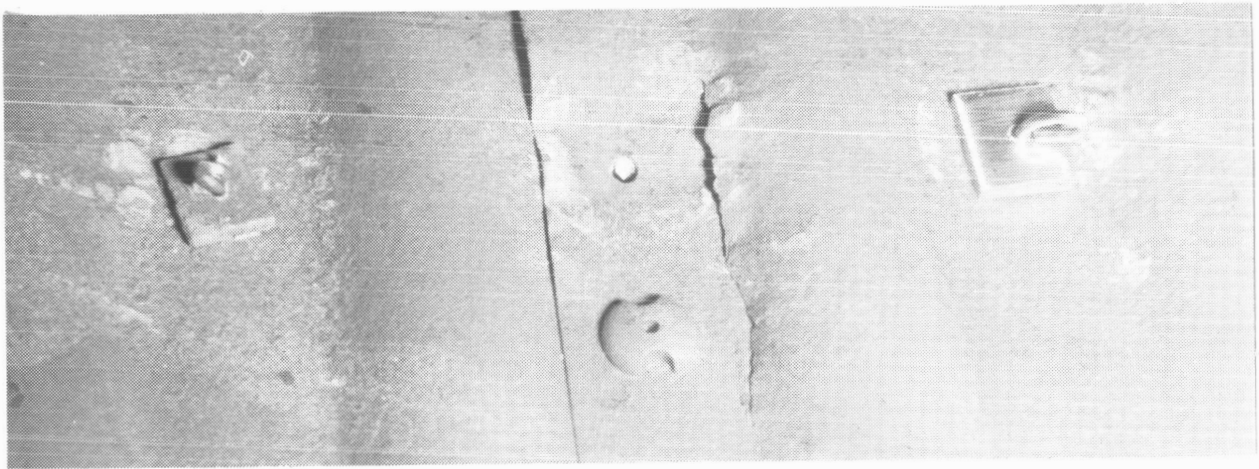
At the conclusion of the 88th cycle, a 3.8-cm (1-1/2-in.) crack was observed along flat No. 7, in the vicinity of load link C-7. The crack was along the intersection of the flat and the bead and right around a loading point. A picture of the crack is shown in Fig. 5-13. There are a number of stress concentrations interacting at this location: there is a large thermal stress due to the flexing of the bead, there is a stress concentration from load point C-7, and there is a stress concentration from

**Fig. 5-13 Surface Crack After 88 Cycles**

the fasteners making the lateral joint running along flat No. 7. Probably, this crack was present for a number of cycles before it was discovered. It was decided to replace the 1.27-cm (0.5-in.) diameter washer at the load point with a larger, rectangular one, and continue the test. This washer was 1.3 by 2.5 cm (0.5 by 1.0 in.).
